# Home Inspection Report

## FICTIONAL SAMPLE PROPERTY

123 Example Residence Lane  
Sometown, NC 00000

**Landmark Inspection Services, LLC**

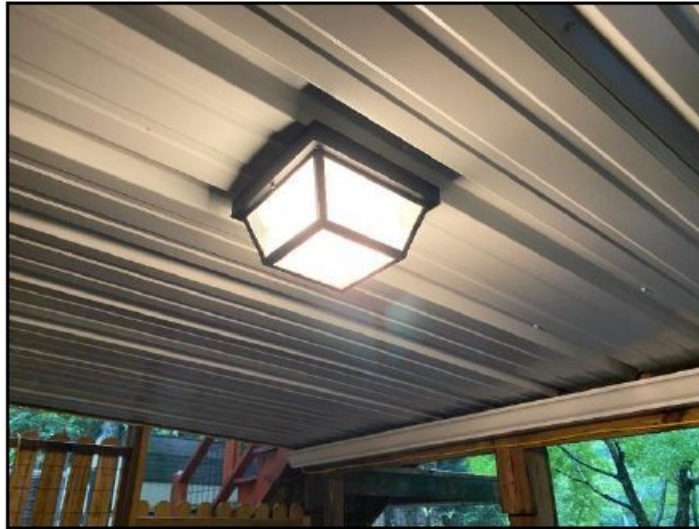
Water intrusion was observed at the metal roof covering over the rear deck. The exact source of leakage could not be determined during the inspection; however, the roof-to-wall flashing and adjoining roof transitions are possible entry points. Continued leakage can contribute to deterioration of framing, finishes, and adjacent materials. Have a qualified roofing contractor evaluate the metal roof installation and roof-to-wall flashing and repair or improve the flashing and roof connections as needed.

*2. Inspect & repair, as needed.*

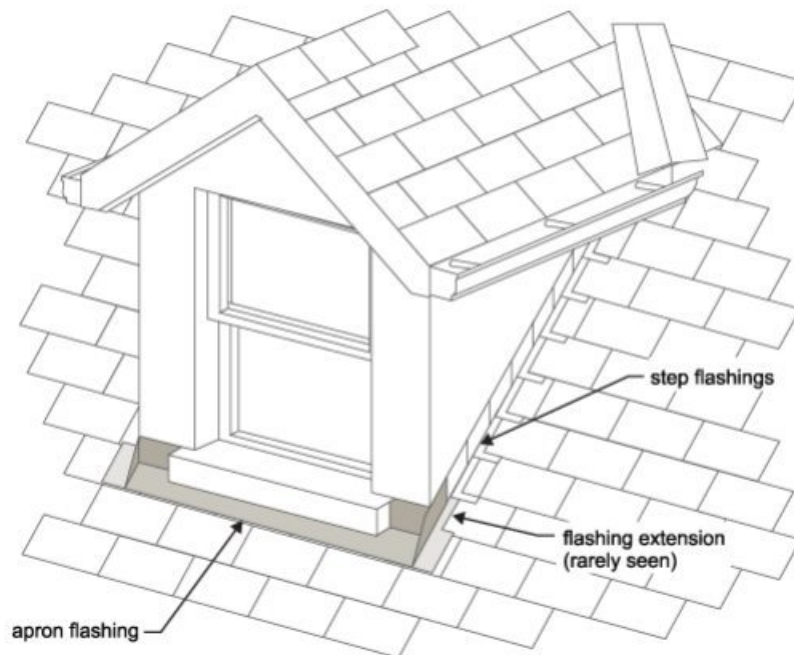
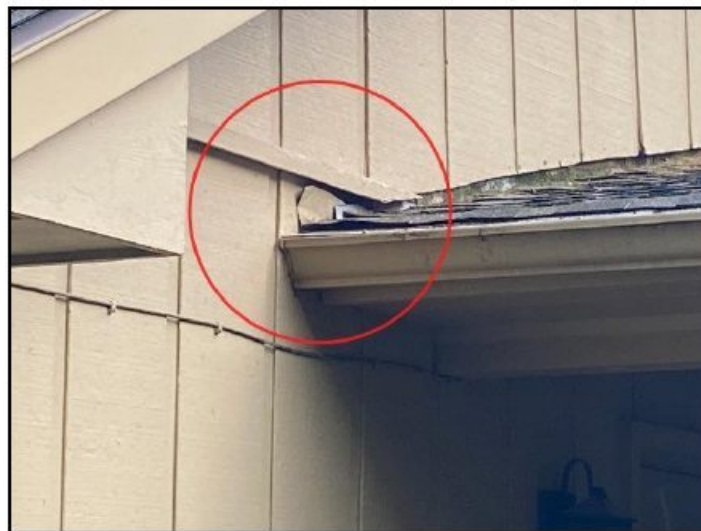
Kick-out flashings were not observed at the applicable gutter/roof-to-wall intersections. Without kick-out flashing, roof runoff can be directed behind or against the exterior wall covering, increasing the potential for concealed moisture intrusion, wood deterioration, and damage to wall materials. Have a qualified roofing contractor install properly integrated kick-out flashing at the affected locations and repair any related flashing deficiencies as needed.

3. Missing

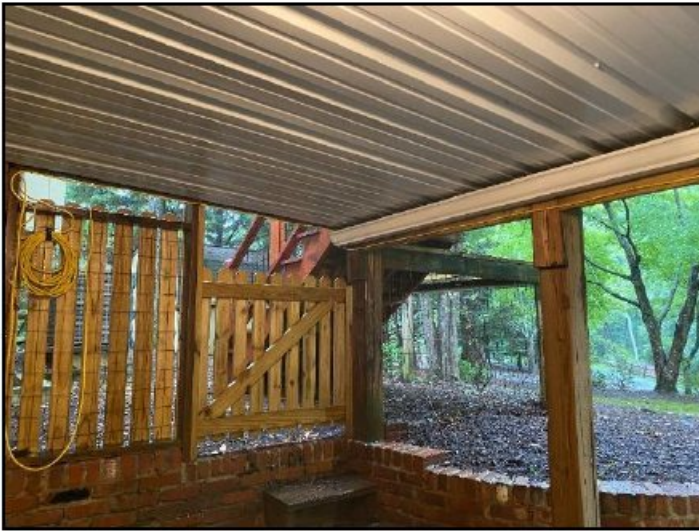
During rain, water was observed escaping or bypassing portions of the roof drainage system at the rear metal-roof addition. The exact point of leakage or overflow could not be isolated and may involve the gutter, roof-edge connection, or adjoining drainage details. Have a qualified roofing/gutter contractor evaluate the gutter and roof-edge drainage arrangement and repair or improve it so roof runoff is reliably collected and discharged away from the structure.

4. Leak

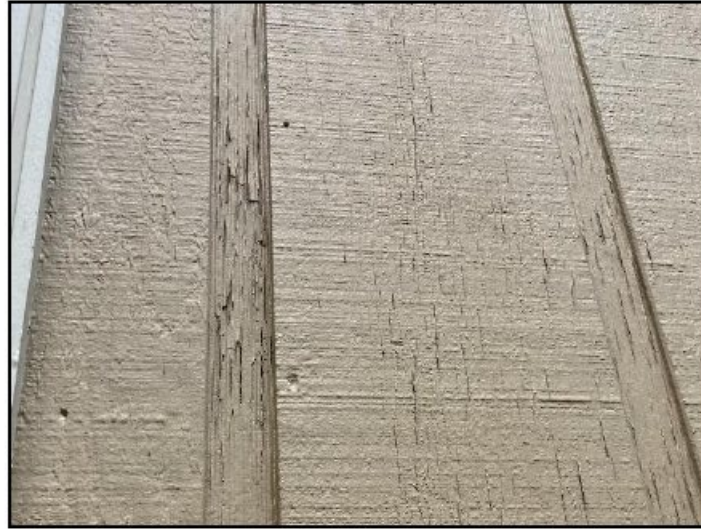
7. Paint or stain - needed

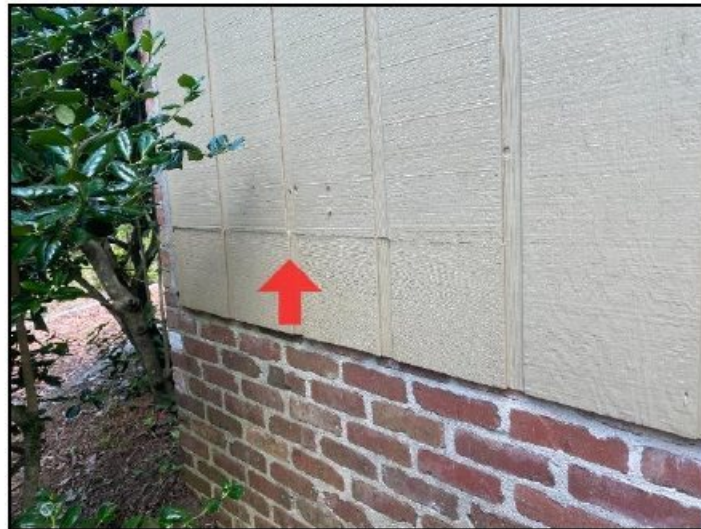
8.

**6. Condition:** • A previously repaired section of exterior wall/siding was observed at the front right portion of the home. The horizontal joint at the repaired area did not appear to be provided with proper flashing or a suitable drainage detail such as Z-flashing. Without proper flashing, water can enter behind the siding and contribute to concealed moisture damage, deterioration, or further wall-system problems. Have the repaired wall section evaluated and properly flashed/sealed by a qualified exterior contractor, with concealed materials checked for damage as needed.

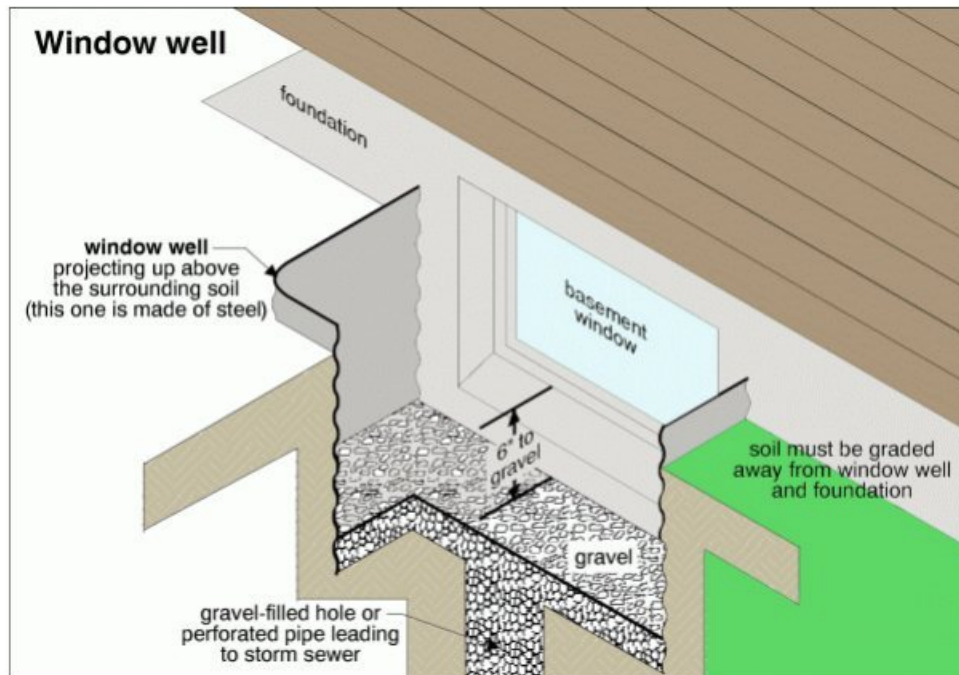
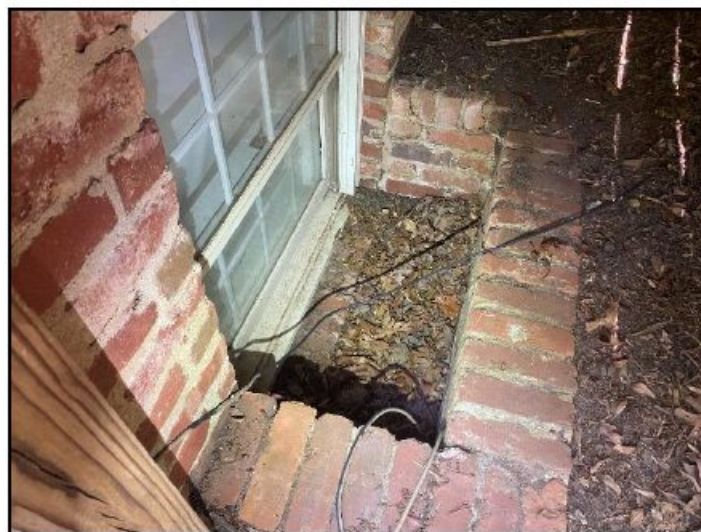
12. Less than 6 inches below window

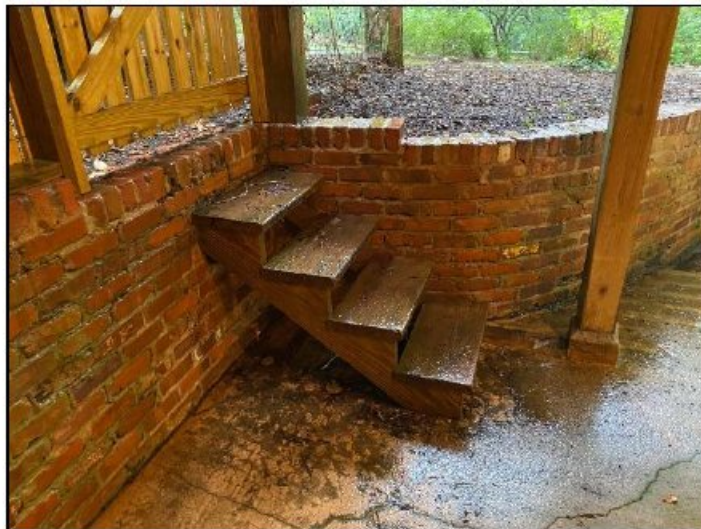
The exterior stairs at the rear patio were not provided with a handrail, and portions of the wood stair assembly were in direct contact with or very close to the soil. The absence of a handrail increases the risk of falls, and earth contact can accelerate moisture-related decay and deterioration of the wood components. Install a properly secured handrail where required and modify or repair the stair assembly to eliminate improper soil contact and provide durable support.

16. *Missing*

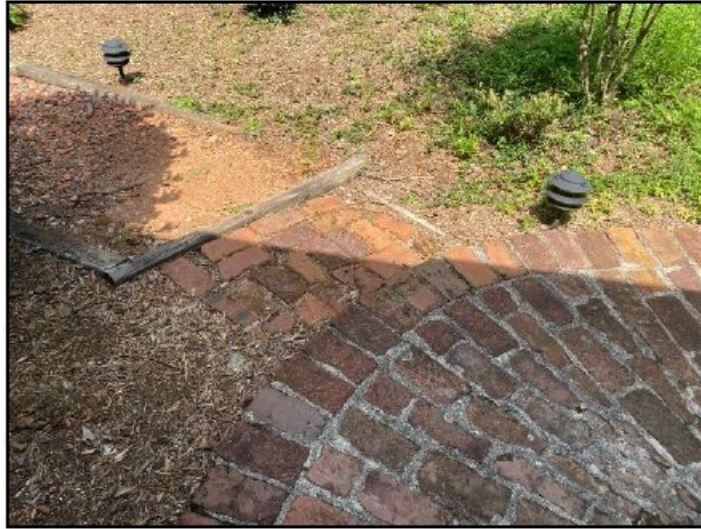
Portions of the exterior brick walkways were uneven and irregular, most notably at the step/transition near the right side of the front entrance leading toward the side driveway. Uneven or displaced masonry at walking surfaces can create a trip hazard and may continue to shift with settlement, moisture, or root activity. Have the affected brickwork reset or repaired as needed to provide a more even and stable walking surface. Other minor uneven areas were also noted along the exterior paths.

19. Uneven (trip hazard)

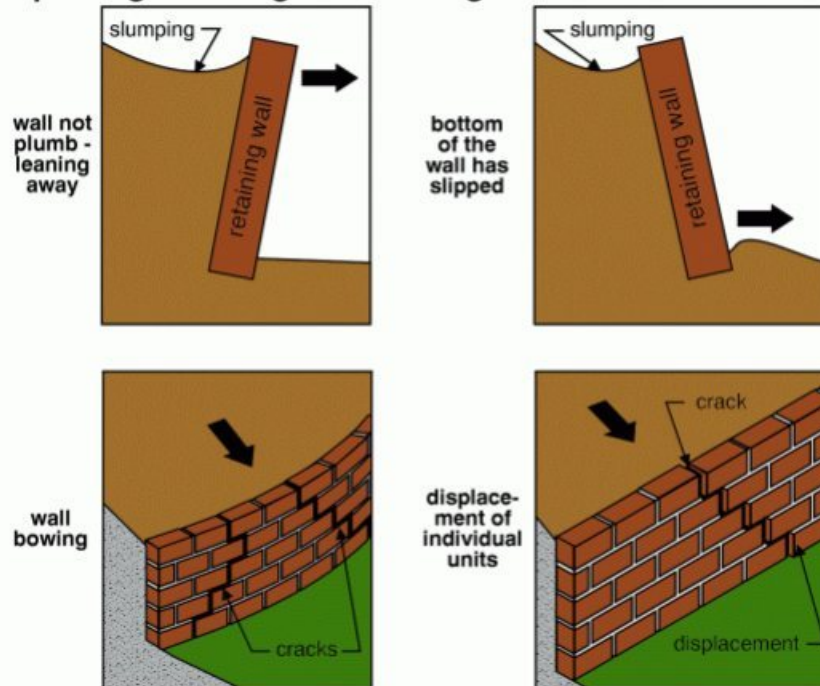
Retaining and landscape walls at the property exhibited movement, displacement, cracking, and deterioration. Conditions included significant leaning/movement of the wood retaining wall near the left front corner of the home and cracking, displaced masonry, and loose/missing bricks at the brick wall bordering the rear walkway. Continued movement can lead to further deterioration or partial collapse and may affect adjacent walking surfaces or drainage. Have the affected walls evaluated and repaired or rebuilt as needed by a qualified masonry/landscape contractor, with drainage and soil pressure conditions corrected as necessary.

20. Leaning

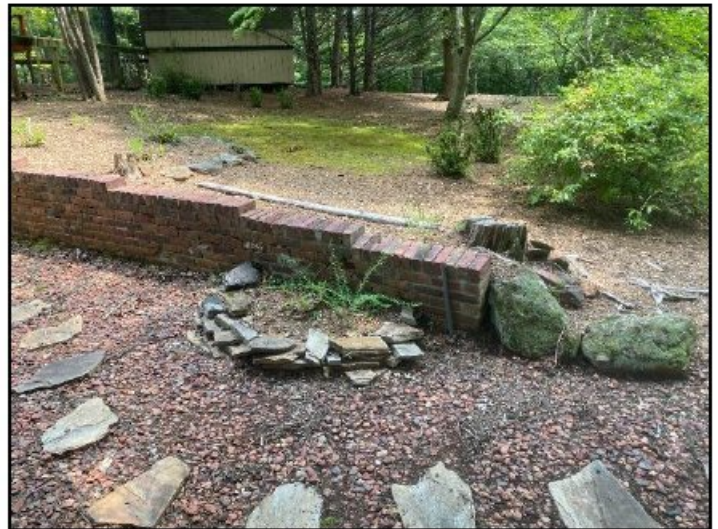
21. Leaning

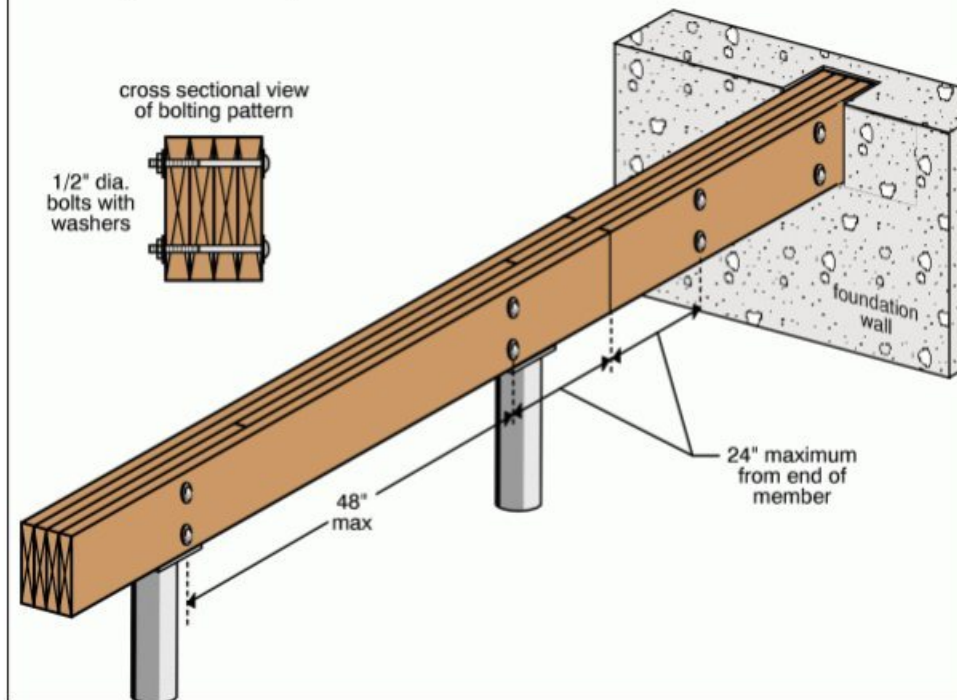
Portions of the floor-support system contained beam/girder splices that did not occur directly over supporting piers. Positive structural connections specifically intended to transfer loads across these splice locations were not evident during the inspection. Pronounced floor slope was also observed in the right-front bedroom above this general area. Previous repairs were evident at the adjoining exterior wall, and insulation concealed portions of the framing, limiting determination of the extent and purpose of prior repairs. The combination of questionable beam splices, observable floor slope, and evidence of previous repairs warrants further evaluation of the floor-support system. Have this area evaluated by a qualified structural engineer and repair or reinforce the framing and supports as recommended.

24. Poor connections in built-up beams

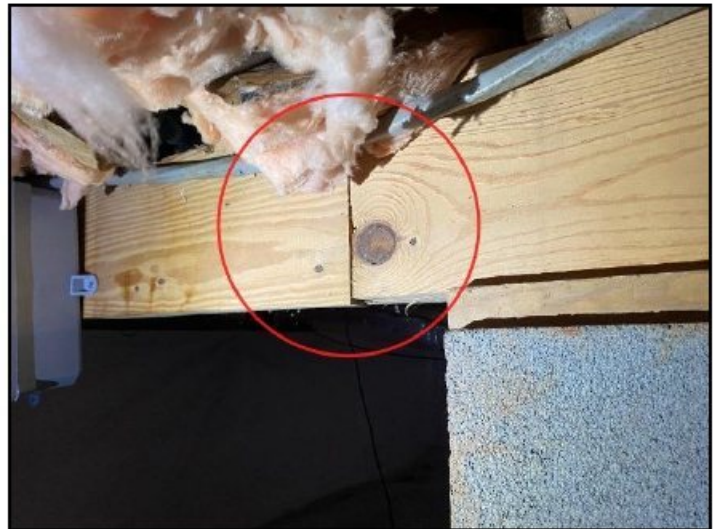
25. Poor connections in built-up beams

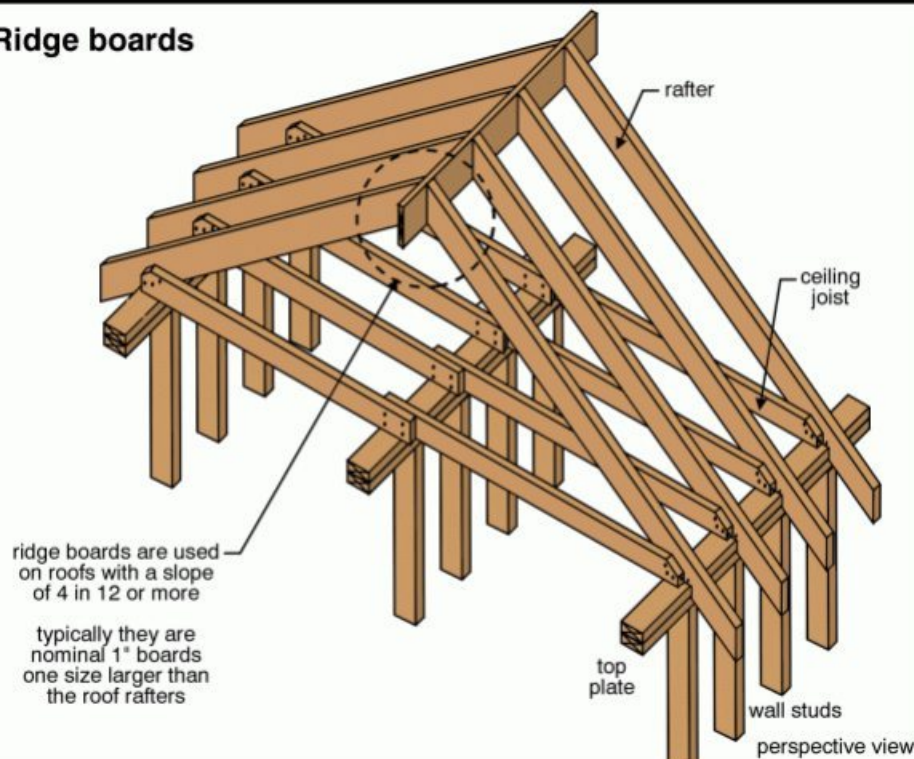
The ridge board was undersized in depth relative to the cut ends of the rafters at portions of the attic. Multiple rafter ends extended below the ridge board and did not obtain full-depth contact at the ridge. This condition can reduce the effectiveness of the rafter-to-ridge connections and may contribute to movement or deterioration of the roof framing.

26. Bearing on ridge board

Have the ridge and associated rafter connections evaluated by a qualified framing contractor and repaired or reinforced as necessary. Because other structural concerns were noted elsewhere in the home, consideration should also be given to having this condition reviewed during the recommended structural evaluation.

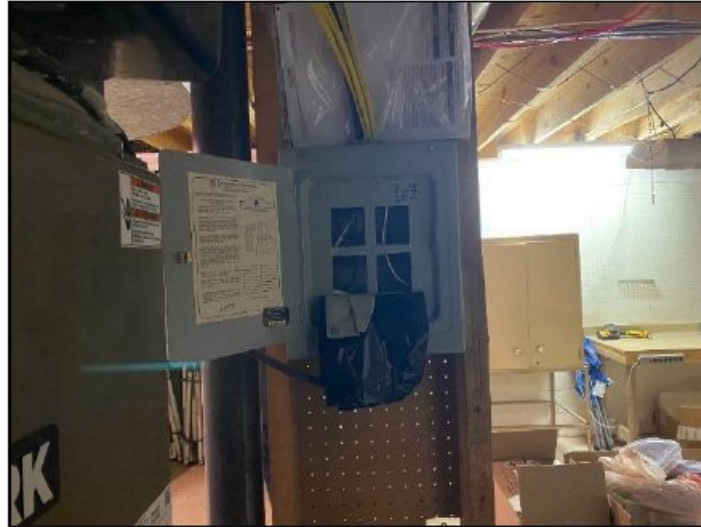
An older electrical panel near the HVAC equipment appeared to have been abandoned as a distribution panel and was being used as a junction/splice enclosure. Multiple unused openings were present in the enclosure/dead-front area, reducing protection from energized wiring and internal connections. Have a qualified electrician evaluate the enclosure and either properly convert and secure it as an approved junction enclosure or replace/remove it as necessary, including closing all unused openings with approved covers.

30. Obsolete service box

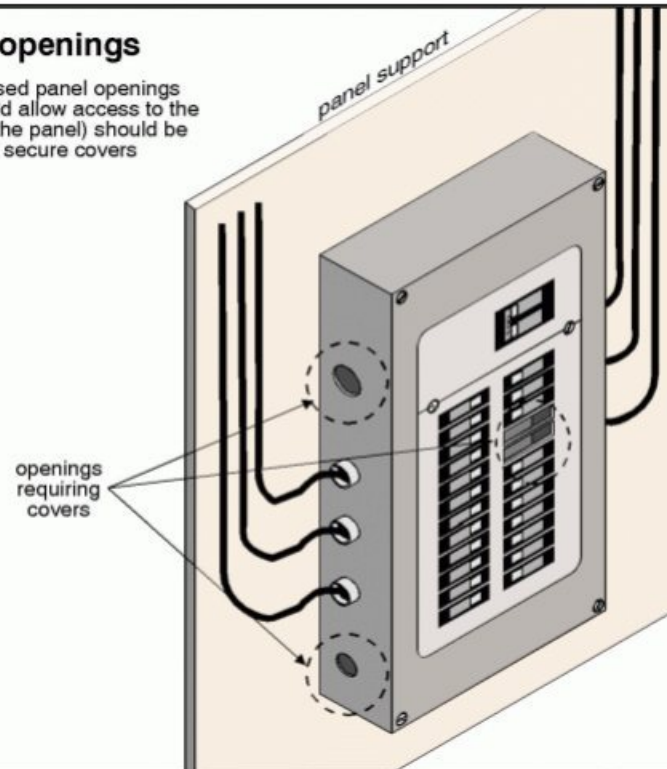
31. Unprotected openings

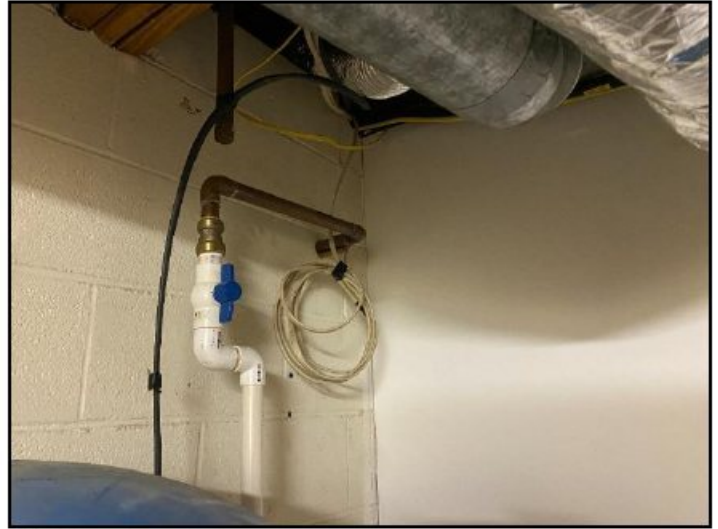
34. Abandoned wire

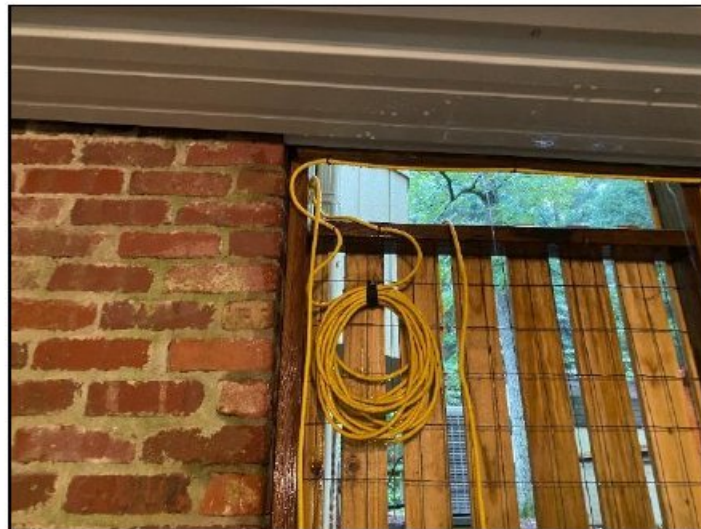
35. Abandoned wire

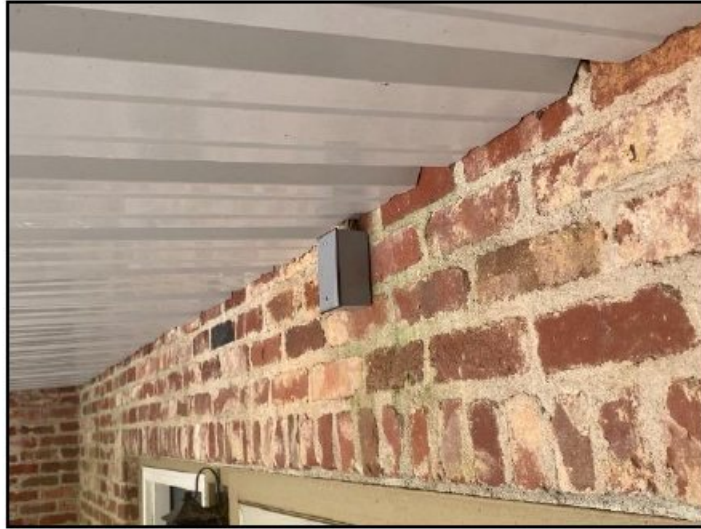
Nonmetallic-sheathed electrical cable serving the exterior junction box at the rear wall above the windows was observed passing immediately adjacent to a sharp metal roofing edge without adequate protection from abrasion or physical damage. Contact with the metal edge could damage the cable insulation and create a shock or fire hazard. Have a qualified electrician provide approved mechanical protection, such as properly installed conduit, bushings, or other suitable guarding, and repair or replace any damaged wiring as necessary.

36. Flexible conduit needed

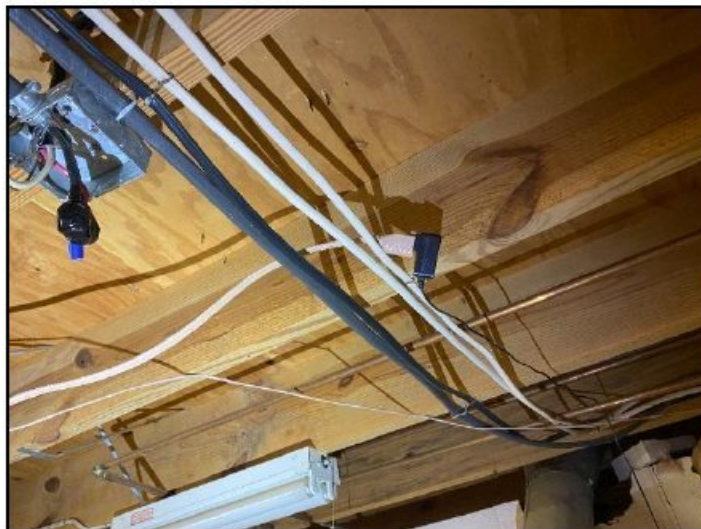
Extension cords and other flexible cord wiring were observed being used in a manner that appeared to serve as permanent wiring at portions of the basement utility room and rear lower patio. Flexible cords are not intended as a substitute for permanent building wiring and may be more susceptible to physical damage, overheating, or improper connections. Have a qualified electrician replace the temporary wiring with approved permanent wiring methods.

37. Extension cord used as permanent wiring

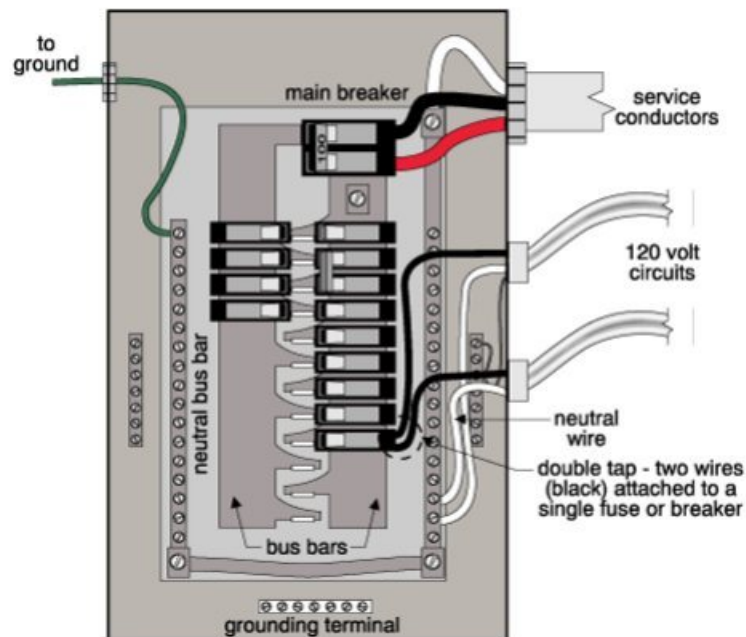
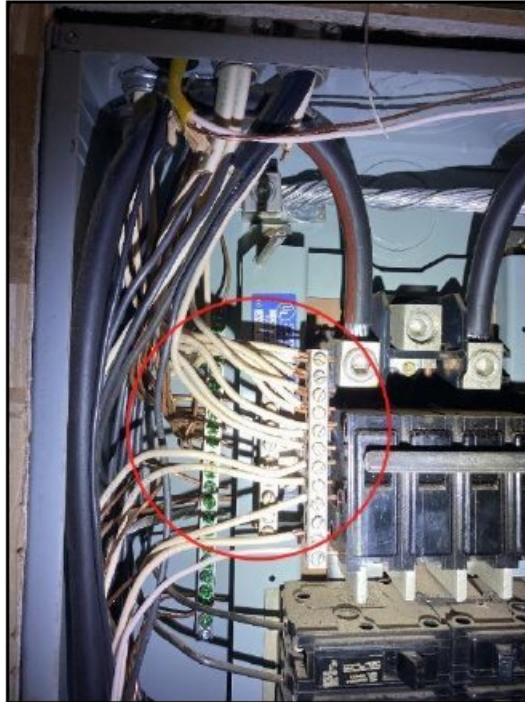
Multiple grounded/neutral conductors were observed terminated under individual terminal screws on the neutral bar. Neutral conductors are generally required to terminate individually unless the terminal is specifically listed for multiple conductors. Improper terminations can result in loose connections, overheating, or unreliable circuit performance. Have a qualified electrician separate the neutral conductors and correct the terminations as required.

38. Double taps

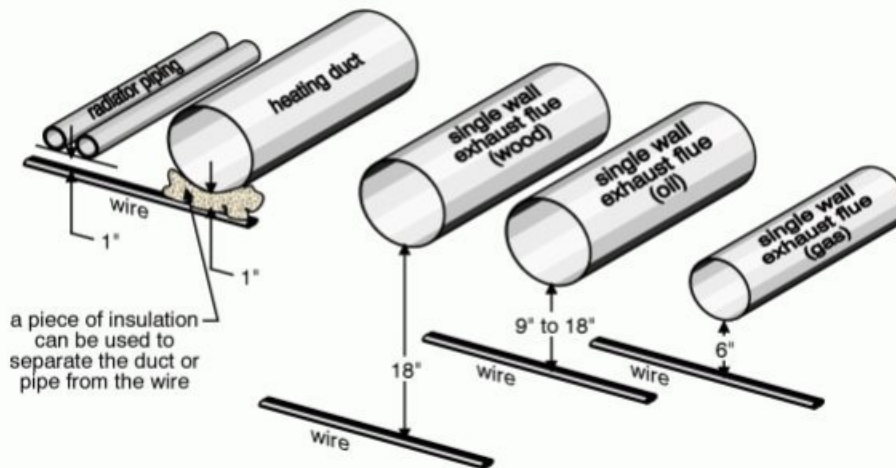
39. Too close to/touching duct, pipe, vent or...

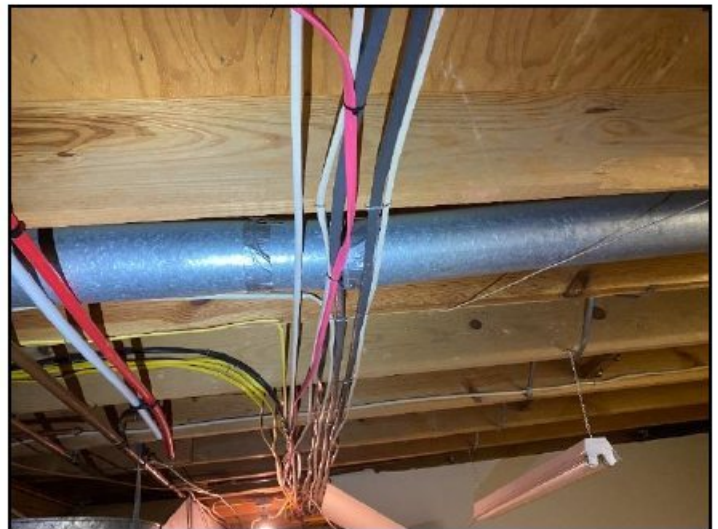
40. Too close to/touching duct, pipe, vent or...

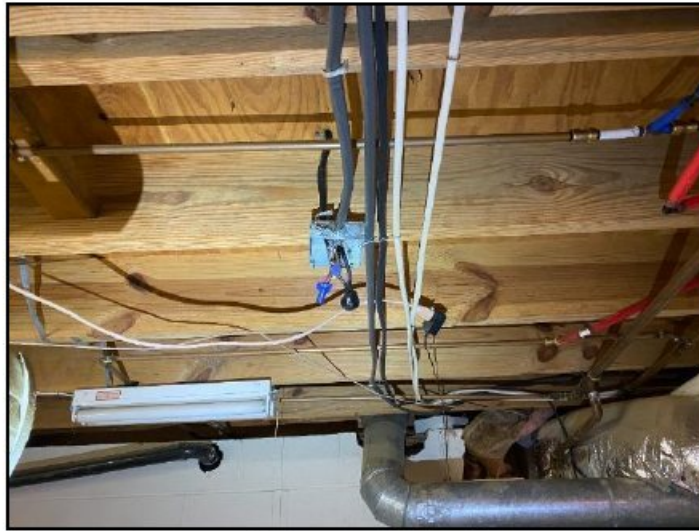
Electrical junction boxes in the basement utility-room ceiling were open and/or missing covers, leaving wiring and splice connections exposed. Exposed electrical connections present shock, arcing, and fire hazards and are susceptible to physical damage. Have a qualified electrician install approved covers and correct any improper wiring or splices within the boxes.

44. Cover loose or missing

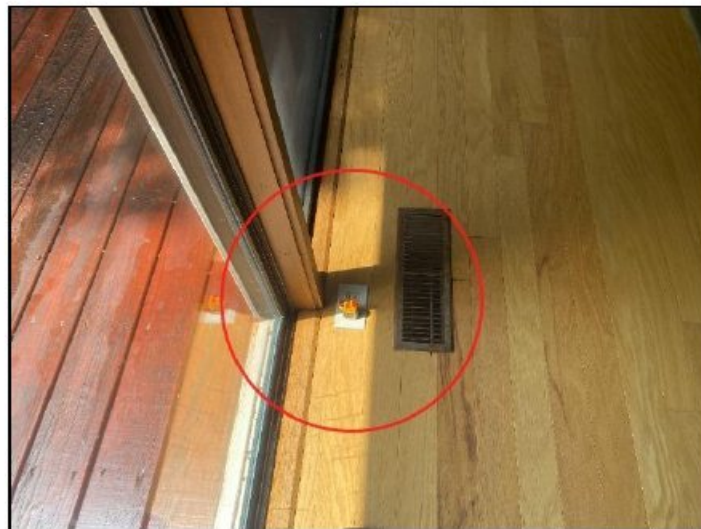
The floor-mounted electrical receptacle adjacent to the sliding glass door was not provided with a proper protective floor-box cover/assembly. An incomplete or damaged floor receptacle assembly can allow moisture, debris, or physical damage to the device and may increase the risk of electrical shock. Have a qualified electrician install an approved listed floor-box cover/assembly and verify proper operation.

45. Wrong type

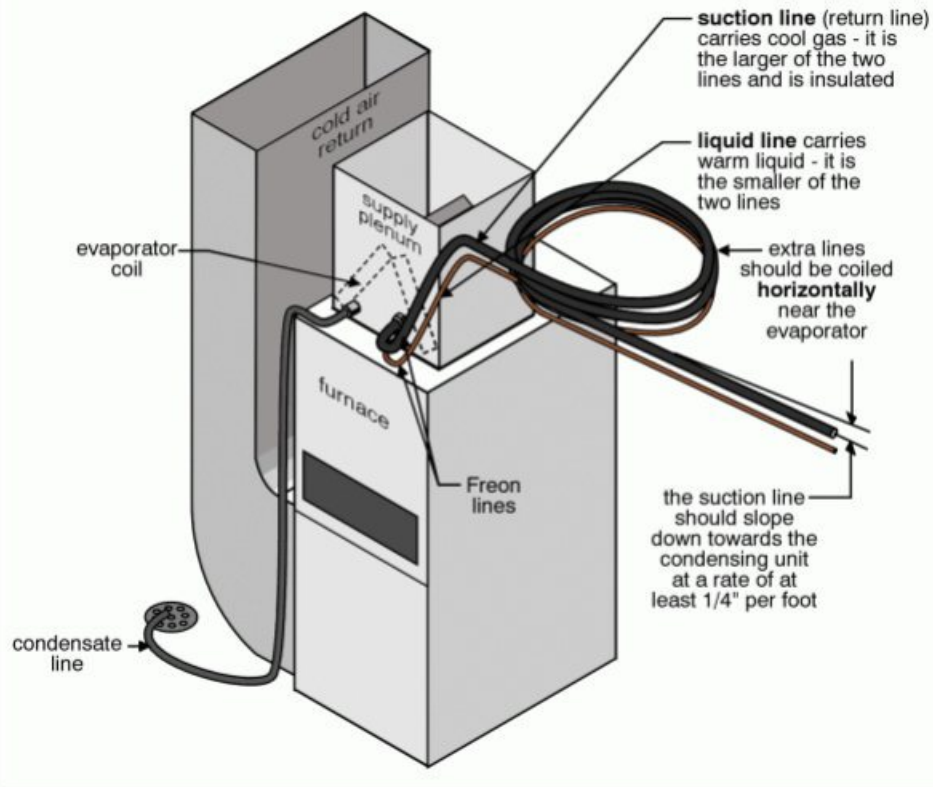
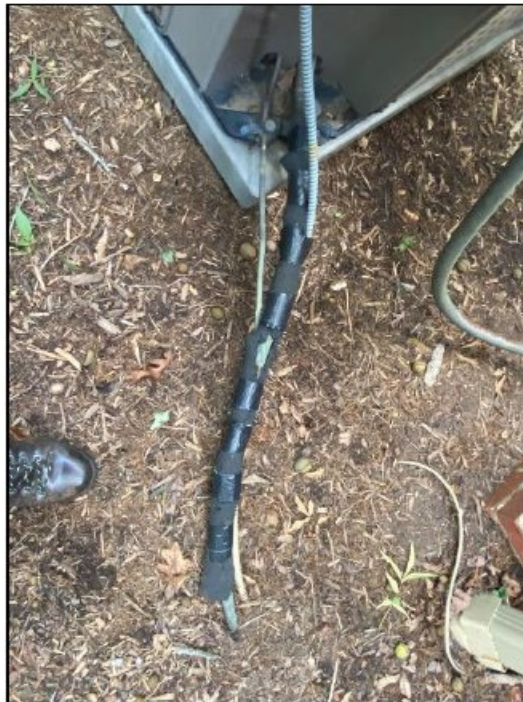
47. Insulation - missing

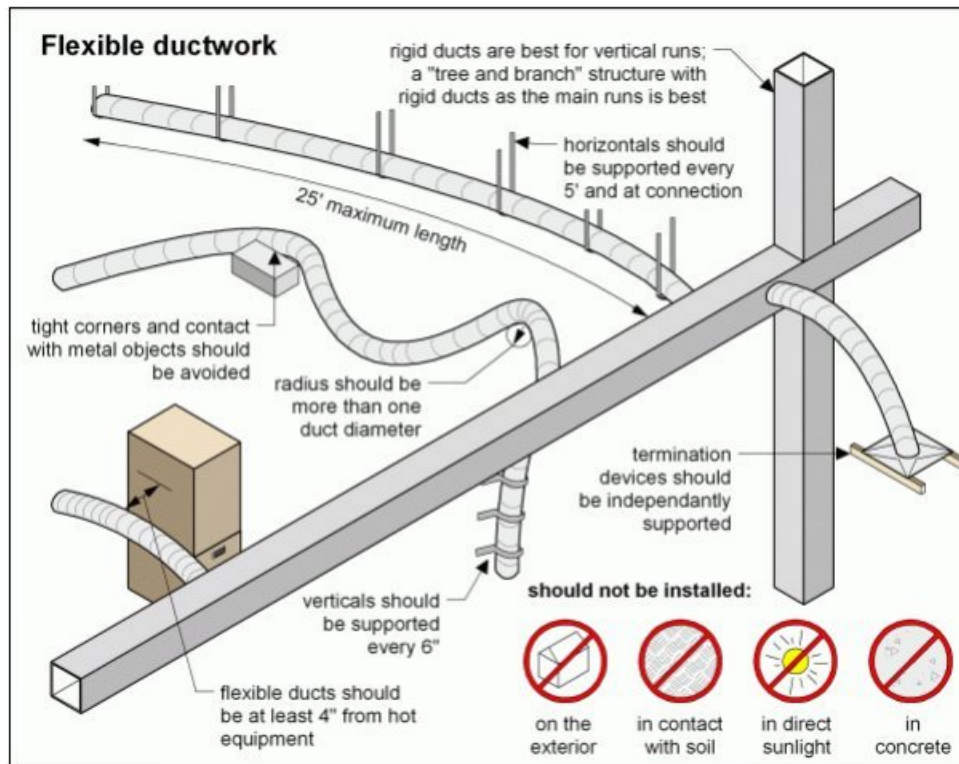
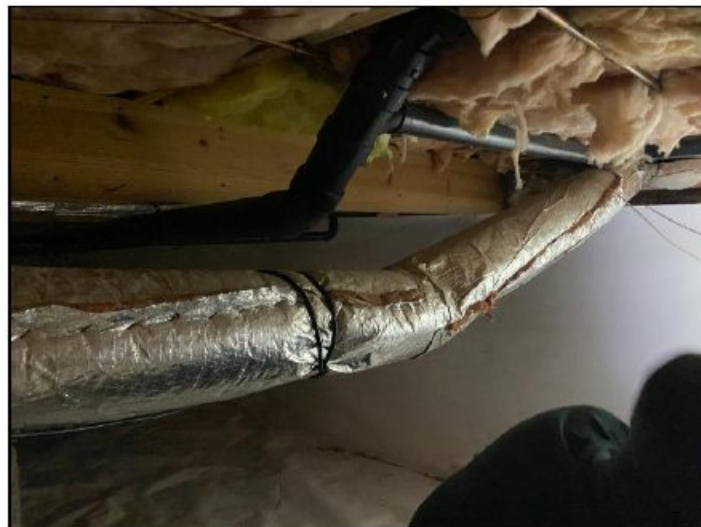
48. Poor support

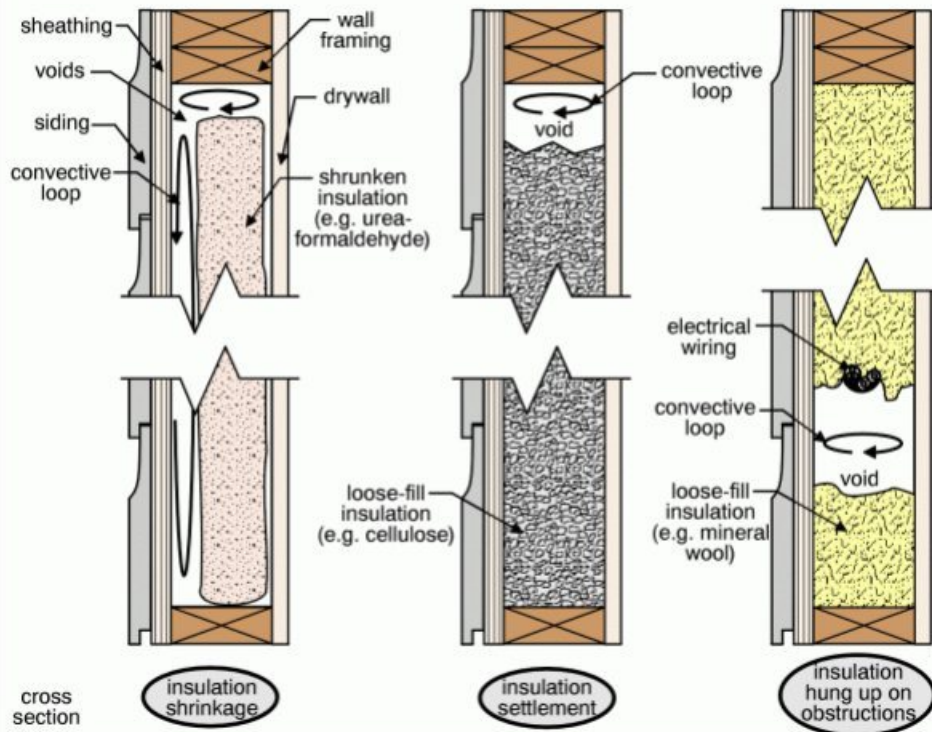
50. Sagging or voids

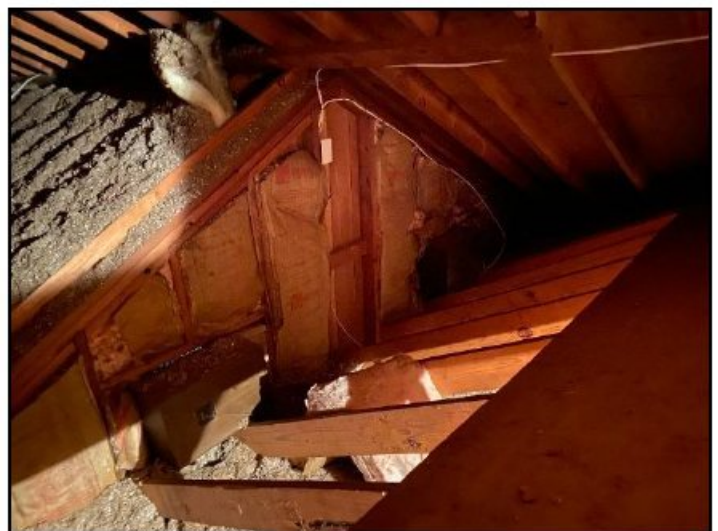
51. Sagging or voids

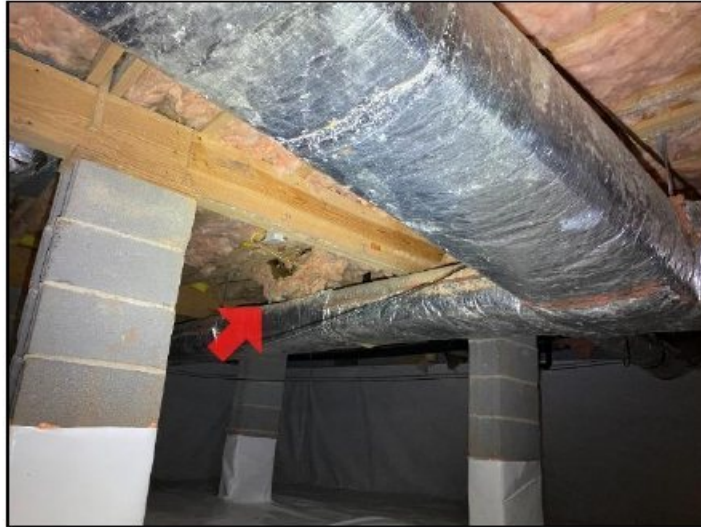
52. Loose, sagging or voids

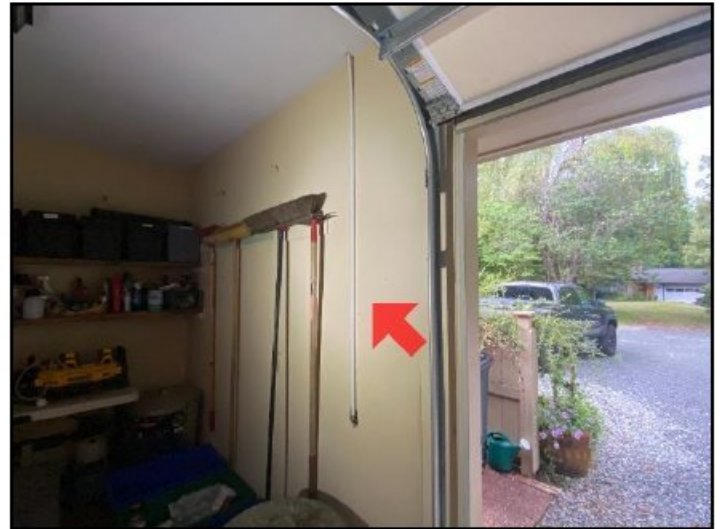
57. Poor support

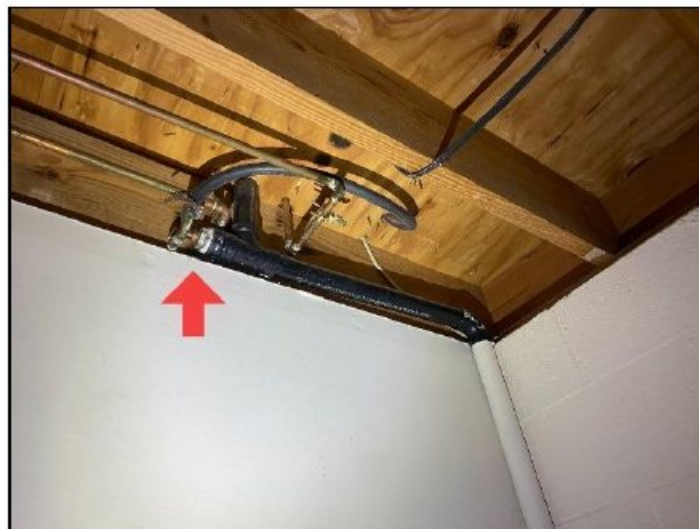
58. Non-standard material

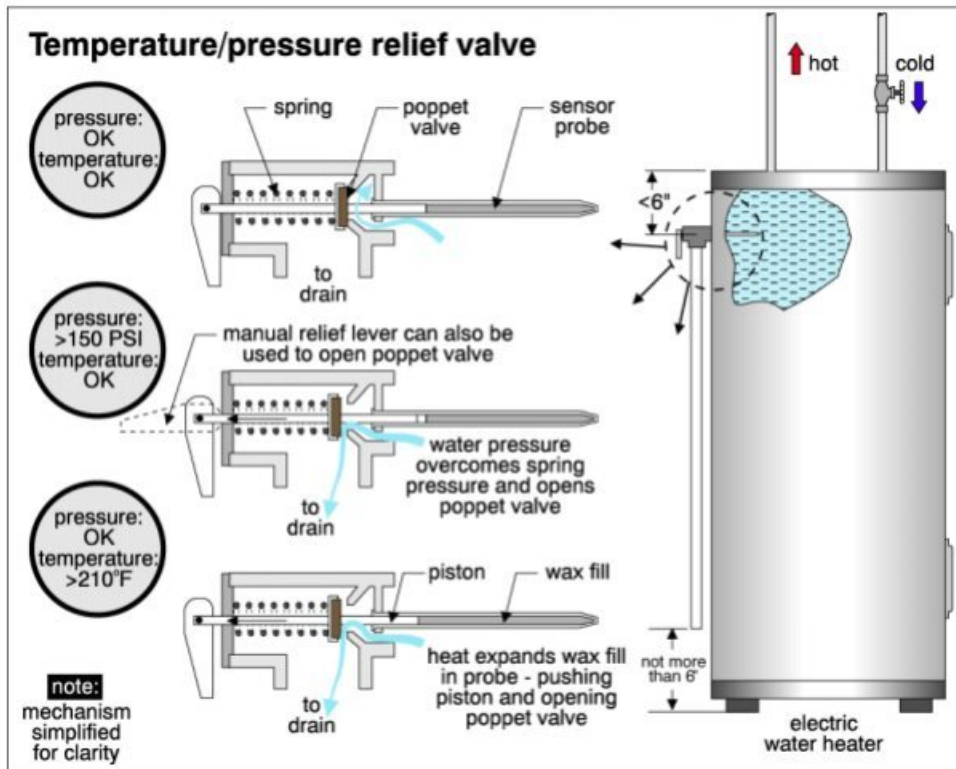
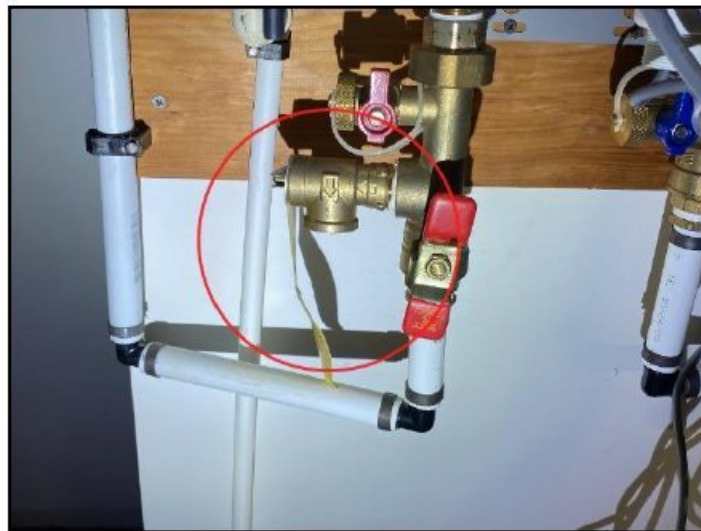
The pressure-relief valve at the water heater was not provided with a discharge pipe. If the relief valve operates, hot water may discharge directly at the appliance, creating a potential scalding hazard and possible water damage. Have a qualified plumber install an approved discharge pipe terminating at an appropriate location.

63. Discharge tube missing

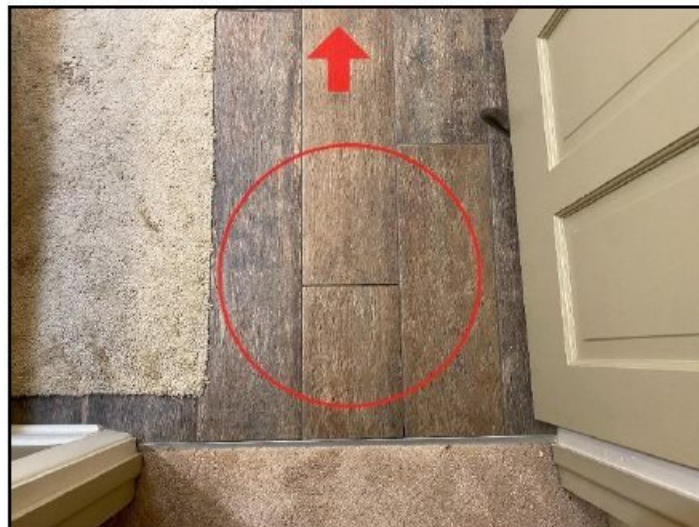
69. Grout missing

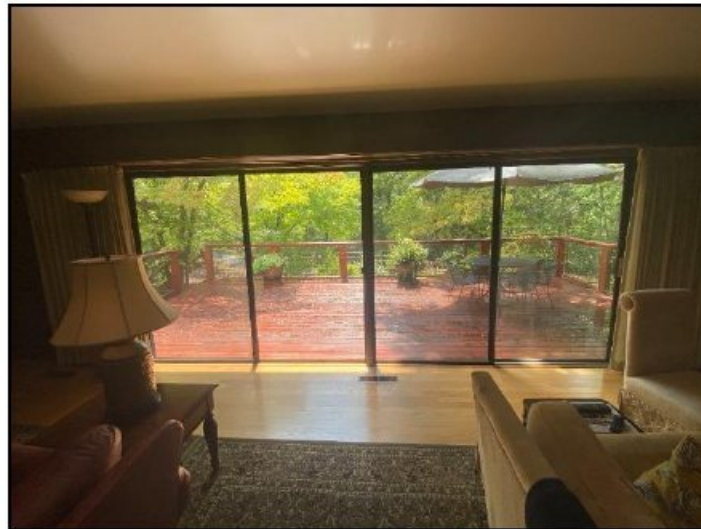
**Condition:** • Safety-glazing/tempered-glass identification was not observed on the sliding glass door panels. Because sliding-door glazing is located where breakage could result in serious injury, have a qualified glass contractor verify whether the panels are safety glazing. Replace or upgrade the glazing if safety glazing cannot be verified or if otherwise recommended by the glass contractor.

72. Safety glass not installed

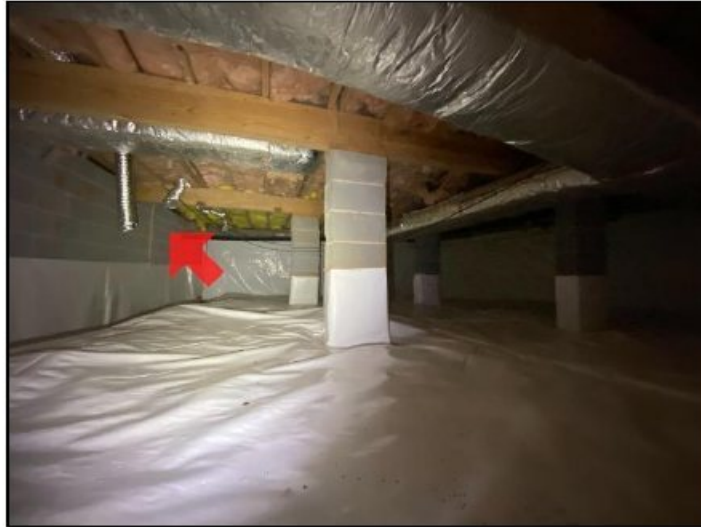
The dryer exhaust duct was disconnected in the right-side crawlspace. A disconnected dryer exhaust can discharge warm, moist, lint-laden air into the crawlspace, increasing the potential for moisture-related conditions, lint accumulation, and fire. Have the duct properly reconnected, secured, and confirmed to terminate at the exterior using an approved dryer exhaust system before continued use.

73. Dryer vent disconnected
