# Home Inspection Report

## FICTIONAL SAMPLE PROPERTY

123 Example Residence Lane  
Sometown, NC 00000

**Landmark Inspection Services, LLC**

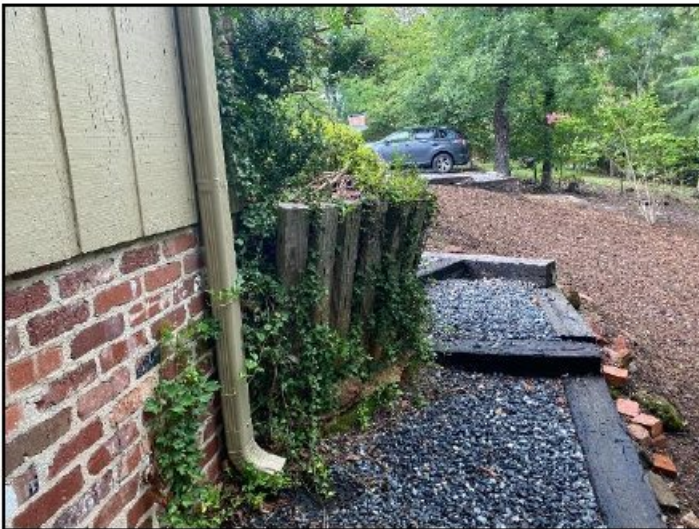
20. Leaning

Retaining and landscape walls at the property exhibited movement, displacement, cracking, and deterioration. Conditions included significant leaning/movement of the wood retaining wall near the left front corner of the home and cracking, displaced masonry, and loose/missing bricks at the brick wall bordering the rear walkway. Continued movement can lead to further deterioration or partial collapse and may affect adjacent walking surfaces or drainage. Have the affected walls evaluated and repaired or rebuilt as needed by a qualified masonry/landscape contractor, with drainage and soil pressure conditions corrected as necessary.

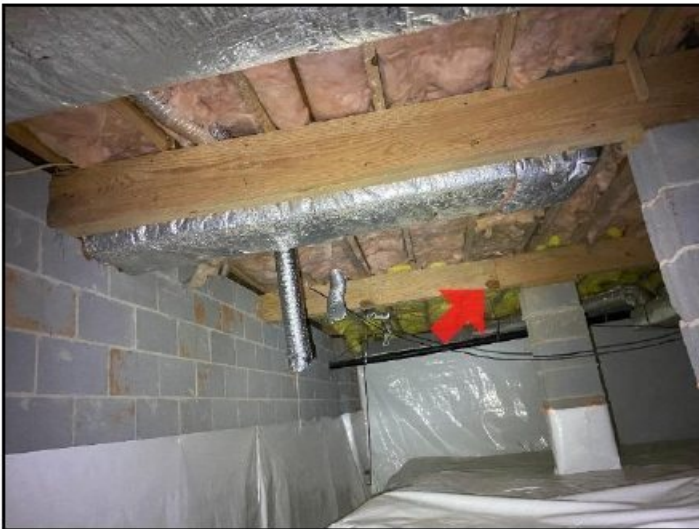
24. Poor connections in built-up beams

Portions of the floor-support system contained beam/girder splices that did not occur directly over supporting piers. Positive structural connections specifically intended to transfer loads across these splice locations were not evident during the inspection. Pronounced floor slope was also observed in the right-front bedroom above this general area. Previous repairs were evident at the adjoining exterior wall, and insulation concealed portions of the framing, limiting determination of the extent and purpose of prior repairs. The combination of questionable beam splices, observable floor slope, and evidence of previous repairs warrants further evaluation of the floor-support system. Have this area evaluated by a qualified structural engineer and repair or reinforce the framing and supports as recommended.

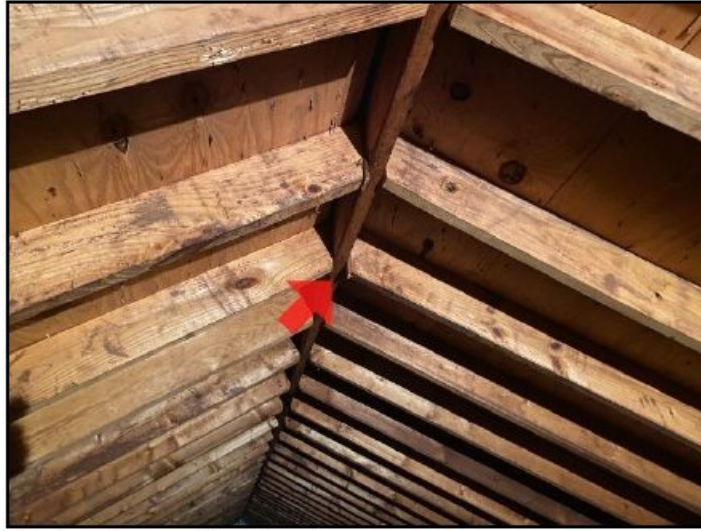
26. Bearing on ridge board

The ridge board was undersized in depth relative to the cut ends of the rafters at portions of the attic. Multiple rafter ends extended below the ridge board and did not obtain full-depth contact at the ridge. This condition can reduce the effectiveness of the rafter-to-ridge connections and may contribute to movement or deterioration of the roof framing.

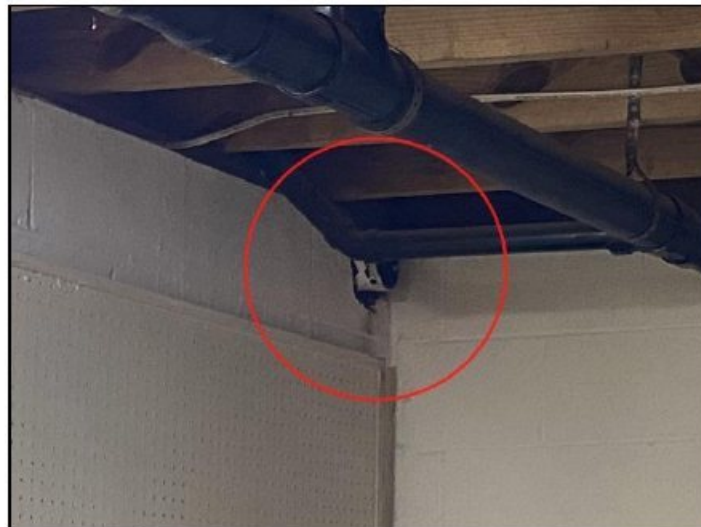
65.

**56. Condition:** • An abandoned or unidentified pipe/opening was observed near the upper portion of the basement utility room front wall. Its original purpose and whether it remains connected to any active system could not be determined during the inspection. Have the pipe evaluated to determine its function and confirm that it is properly disconnected, capped/sealed, or otherwise terminated as appropriate.

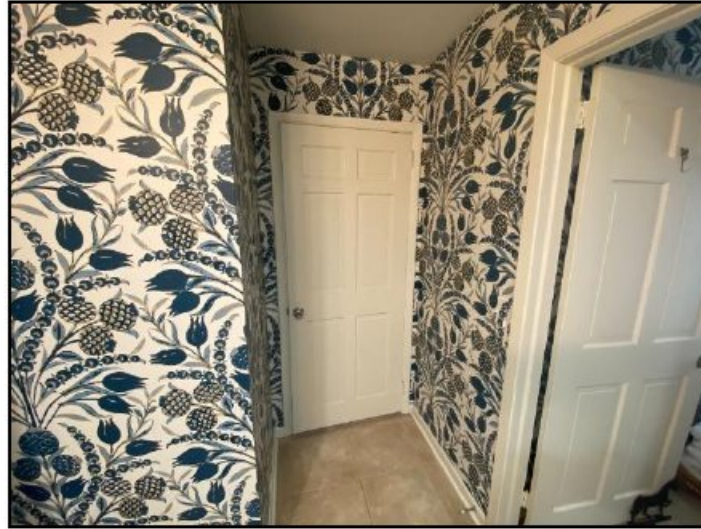
71. Binds
